Residential Seismic Safety Program

The Apartment Owner's Guide to Earthquake Safety

**A Handbook for Owners to Identify
Seismic Hazards in Low Rise Apartment Buildings**

Steven M. Vukazich, S.E., Ph.D.
San Jose State University

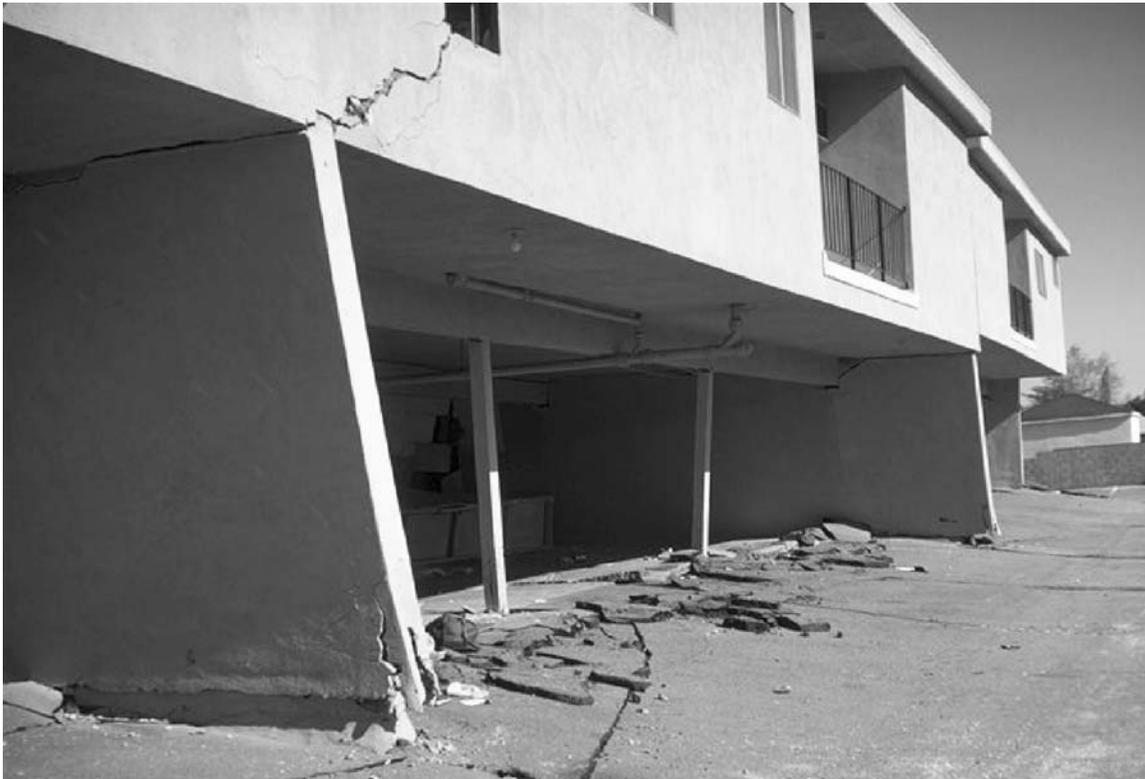
Figure 3. Damage to a tuck-under parking building with stucco shearwalls

Stucco and gypsum board shearwalls coupled with tuck-under parking are present in many wood framed apartment buildings built prior to 1976. The primary reason for this is that the 1976 edition of the UBC contained revisions due to observed performance of buildings in the 1971 San Fernando earthquake. The most significant of these revisions was to decrease the allowable strength of both stucco and gypsum board shearwalls and to increase the seismic load by forty percent. The direct result was the increased use of plywood shearwalls in wood construction and while tuck-under parking was not eliminated it was discouraged. Figure 3 shows damage to stucco shearwalls in a tuck-under parking building following the San Fernando Earthquake. All of the damaged multi-unit buildings inspected after the Northridge earthquake had failed stucco or gypsum board shearwalls. The performance of these weak shearwalls was often made worse by sloppy construction and poor quality control.

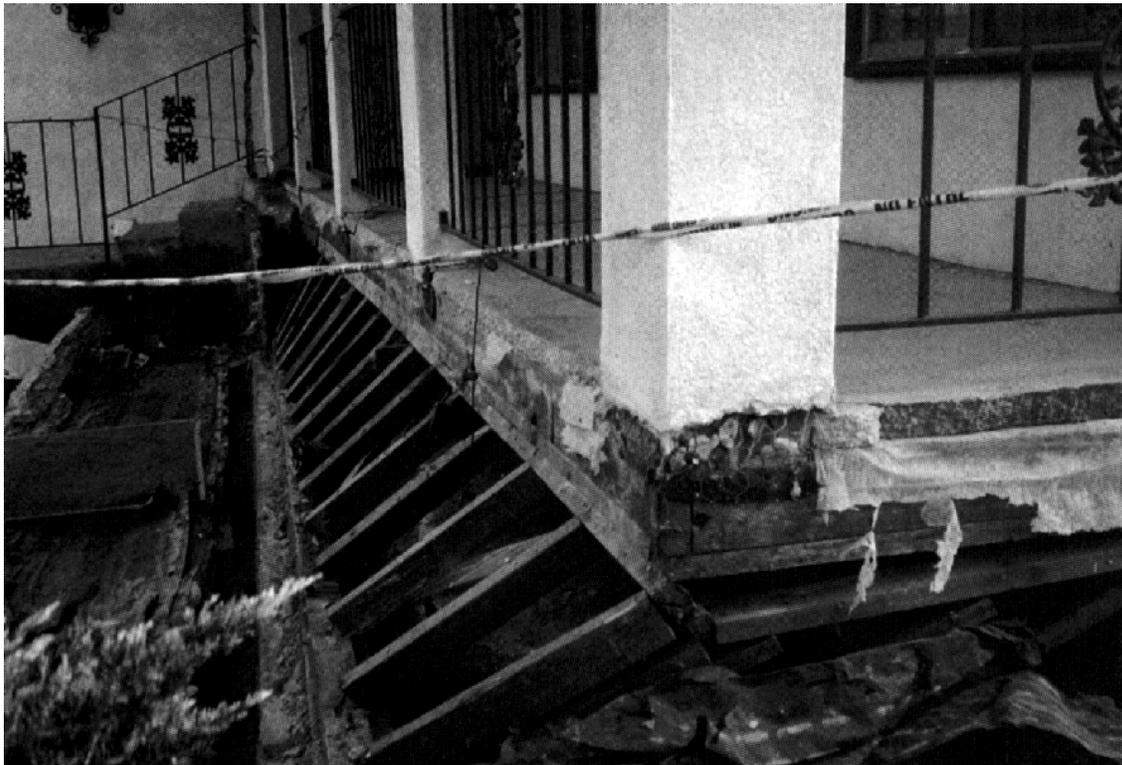
Figure 5. Cripple wall damage in the Northridge earthquake

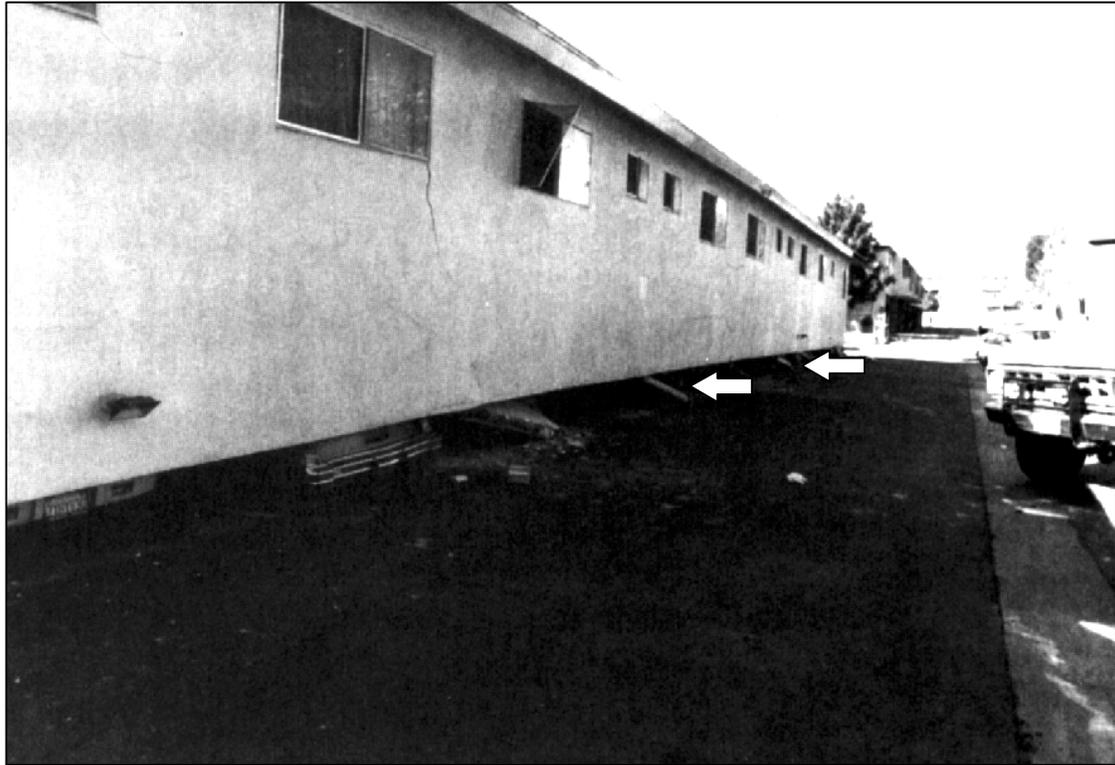
Figure 6. Damage to a tuck-under parking building in the Northridge earthquake.

quate to resist the seismic forces and subsequent large deformation that they are subjected to in a major earthquake. Figure 6 shows a tuck-under parking building that collapsed during the Northridge earthquake. Note the collapsed steel posts indicated by the white arrows and the upper stories remaining almost completely intact. This figure illustrates the inherent weakness of the tuck-under parking configuration and the dangers to human life and property (16 people died in this particular building).

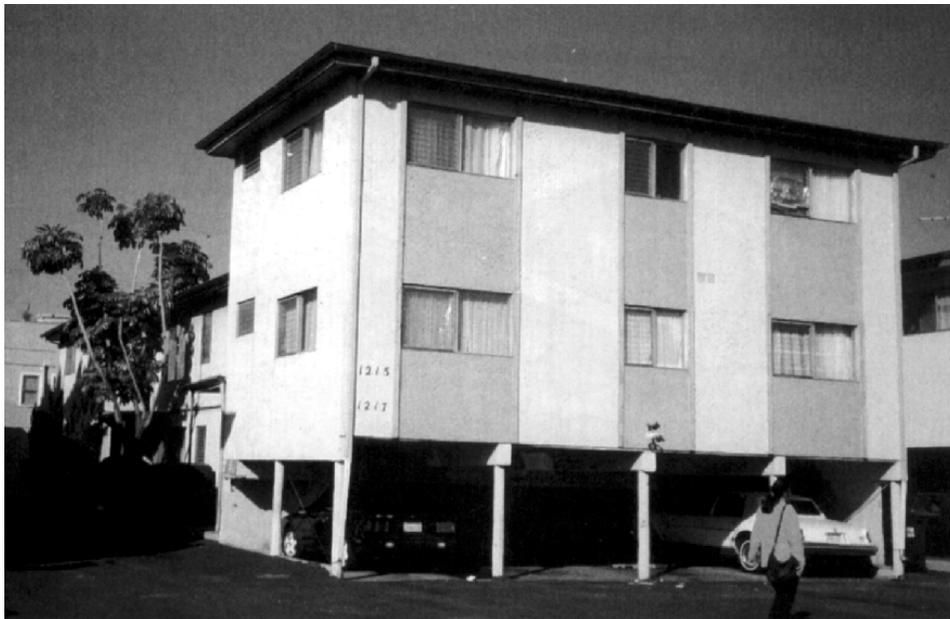
Figure 12. Photo of building for RSP example.

In order to illustrate the RSP and how to fill out the Data Collection Form, the following example is presented. A photo of the example building is shown in Figure 12 and the completed Data Collection Form for this building is shown in Figure 13.
